AGC Glass-Kingsport Plant-SKV/GKT-Spill Investigation-8/6/12

AGC Glass-Kingsport Plant-Spill Investigation-SKV/GKT-8/6/12

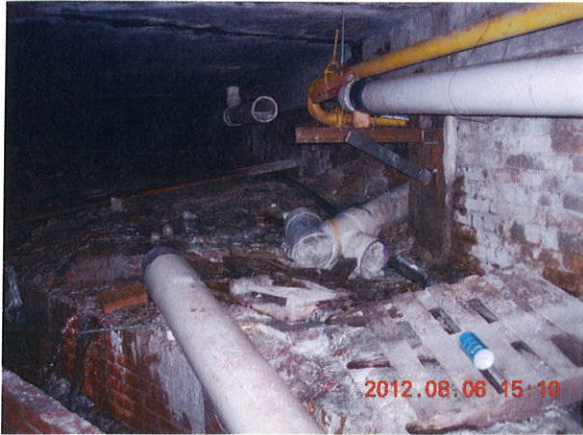
PVC Line Break Location (Building No. 43)

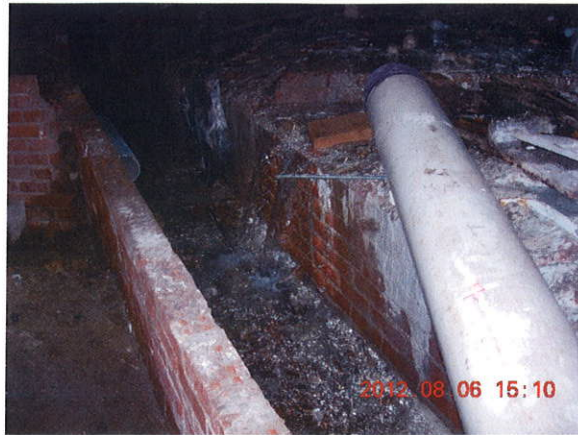
Flow entering trench

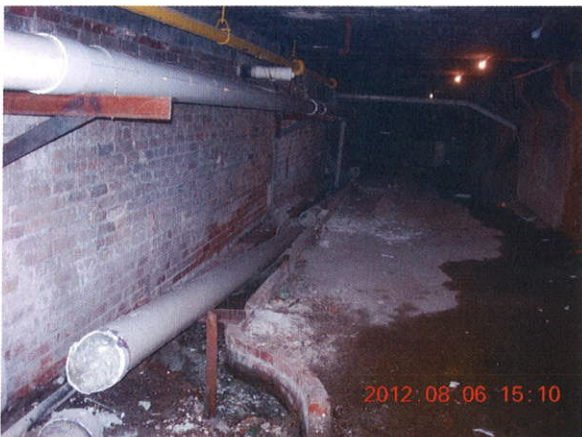
Flow in trench toward basement

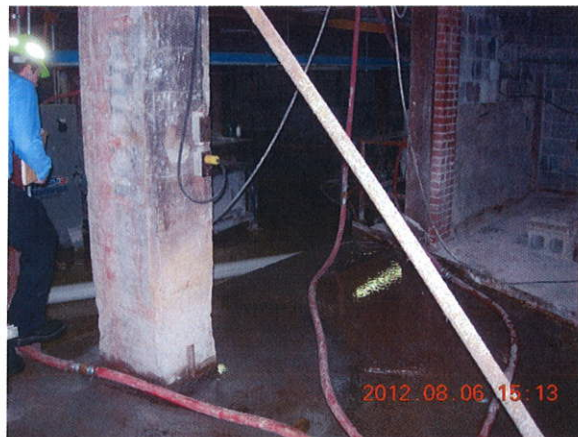
Flow on basement floor

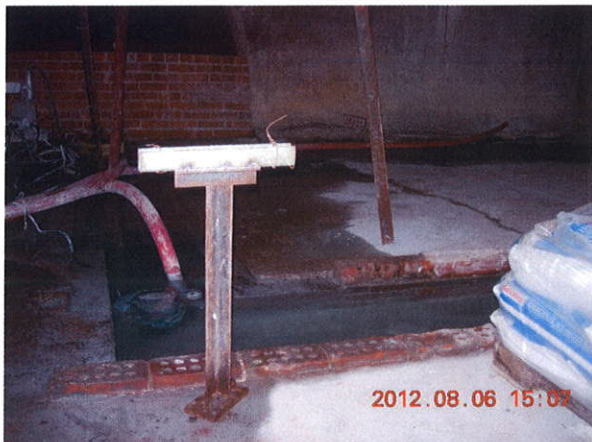
Sump pump in trench

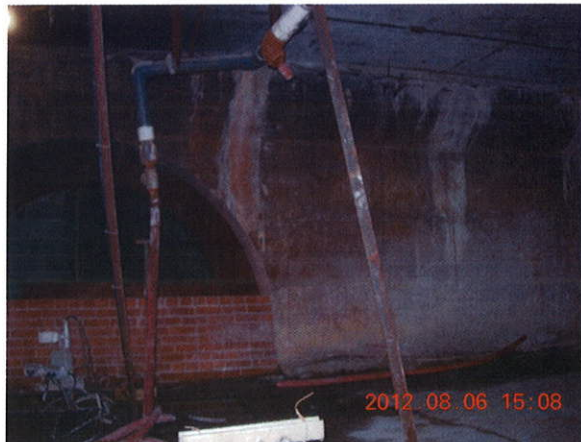
Sump pump line

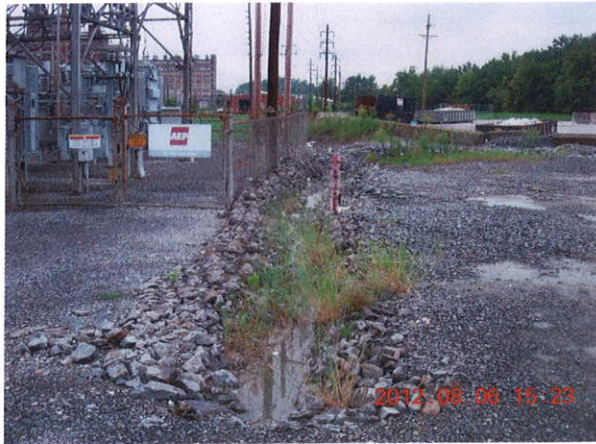
Ditch toward outfall SW2

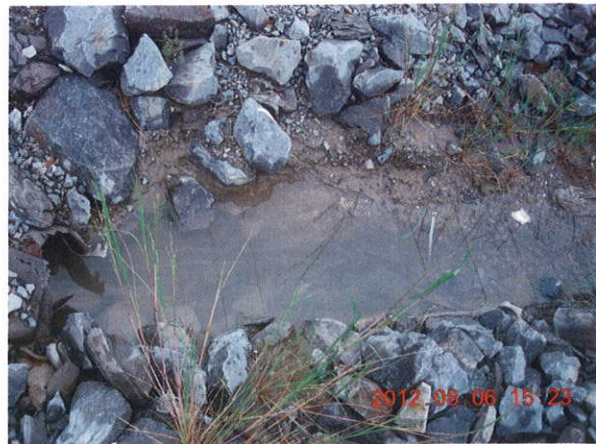
Flow in ditch/pH sample location

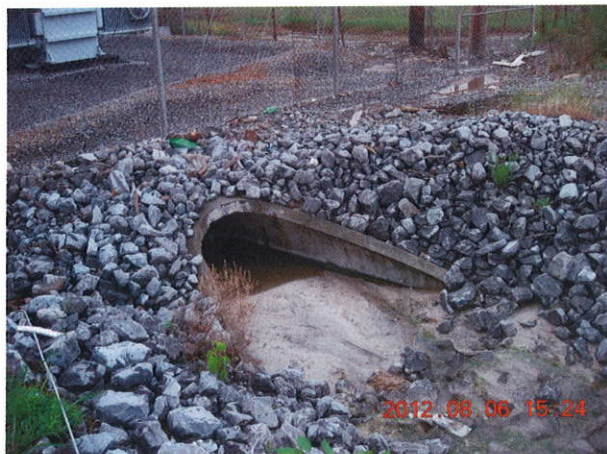
Culvert blocked with sediment and trash

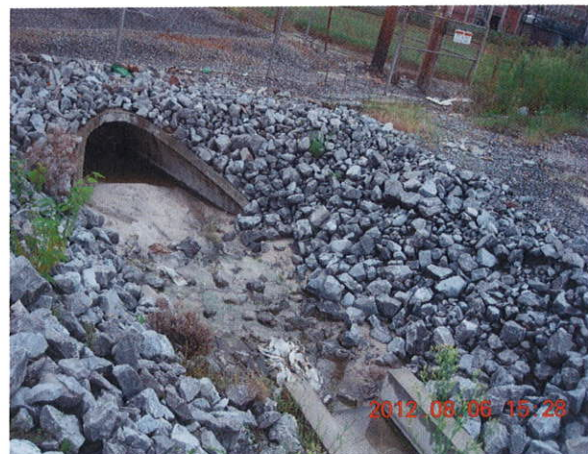
Flow entering culvert

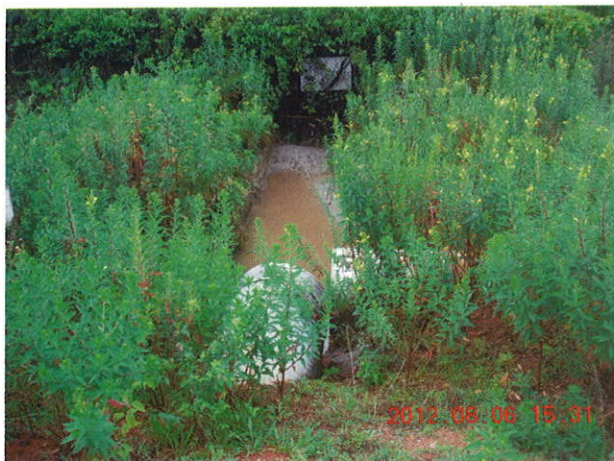
Outfall SW2-blocked with sediment

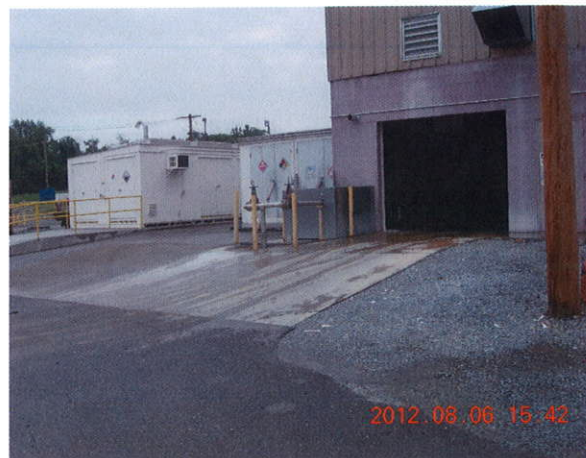
Rear of Building No. 43-no flow coming out
